Subject: Clean Water Act Compliance Evaluation Inspection Report

CWA COMPLIANCE EVALUATION INSPECTION REPORT
U.S. ENVIRONMENTAL PROTECTION AGENCY, REGION 5

Facility: Calamity Knoll

Date of Inspection: April 24, 2014

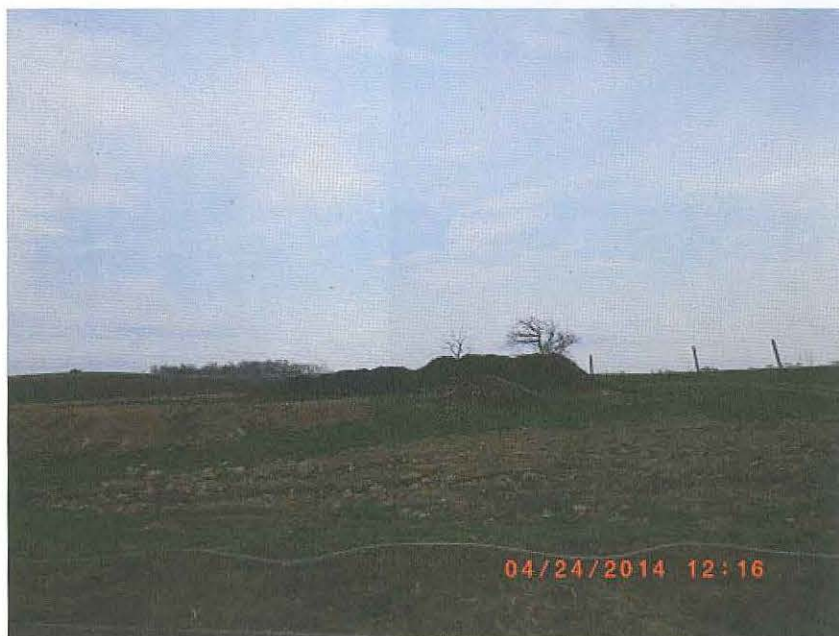
42: IMGP0668

Description: The mortality compost pile can be observed in the background. The mortality compost pile was not covered. Process wastewater from the compost pile had no containment.

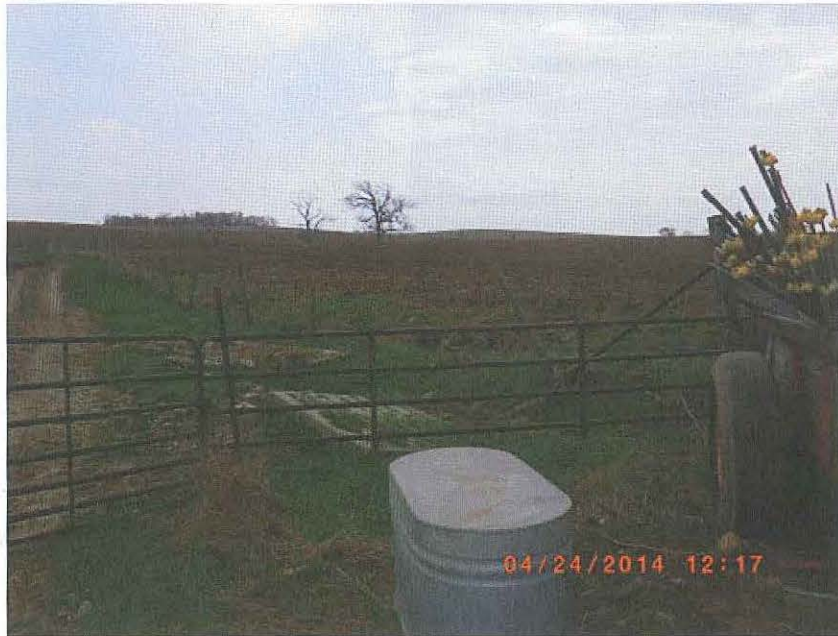
45: IMGP0671

Description: Drainage pathway flows east through this area.

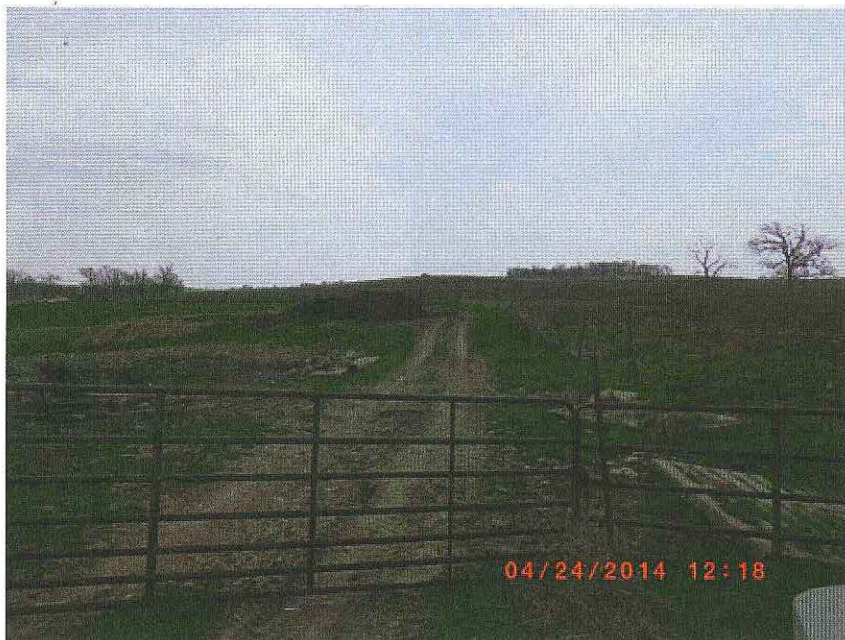
47: IMGP0673

Description: Mortality compost pile is located in the background. The mortality compost pile was not covered. Process wastewater from the compost pile had no containment.

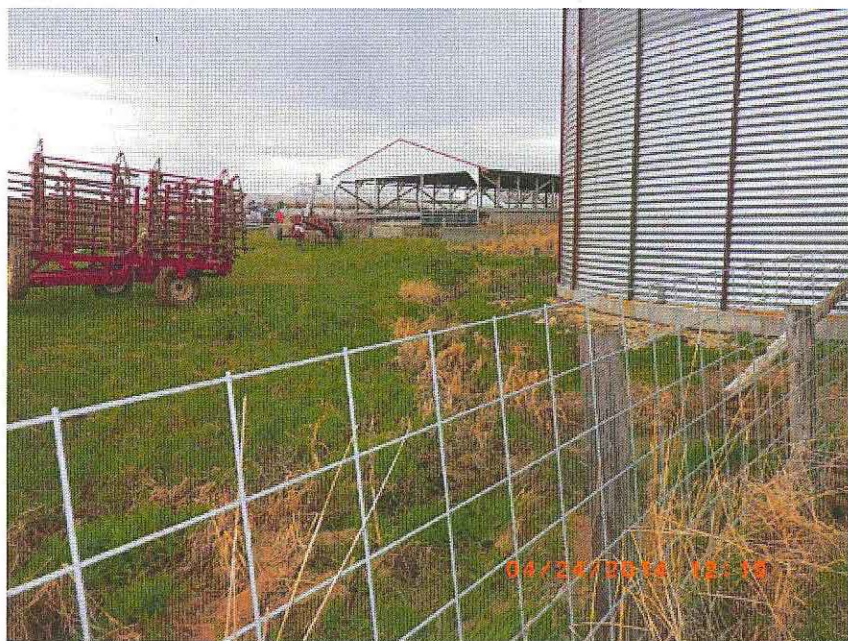
48: IMGP0674

I observed dead vegetation throughout the drainage pathway draining from east of the Hartgarten and Cow Palace barns (Attachment 2: IMGP0674). I observed manure and bedding solids throughout the pathway that came around both the south and the north end of the Silos (Attachment 2: IMGP0674; IMGP0684; IMGP0685). The drainage pathway continued east through a culvert under an access road (Attachment 2: IMGP0682). I observed manure and process wastewater at the inlet of the culvert, near the outlet of the culvert and in the drainage pathway (Attachment 2: IMGP0675; IMGP0676; IMGP0681; IMGP0683). The drainage pathway flows east and northeast to Spring Brook. The open lot between the Bruce Barn and Robbie's Pen drained to the east/northeast (Attachment 2: IMGP0687).

Description: Surface drainage flows east through this grassed area around the grain bins. Vegetation was dead throughout the pathway. Manure solids were observed throughout the pathway.

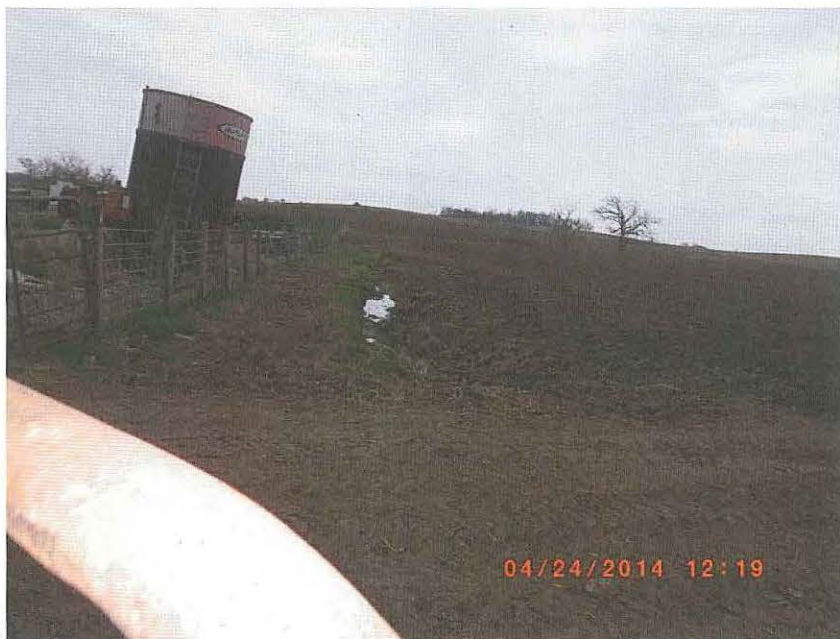
49: IMGP0675

Description: The surface drainage from the grassed area drains through a culvert under the access road and continues east through a pathway.

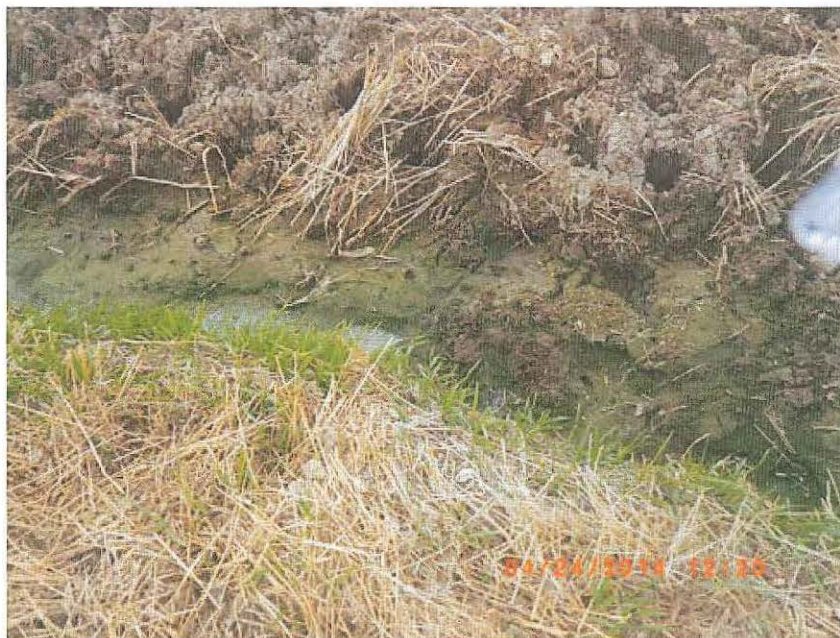
50: IMGP0676

Description: The pathway contained manure solids and was dark in color. It smelled of manure.

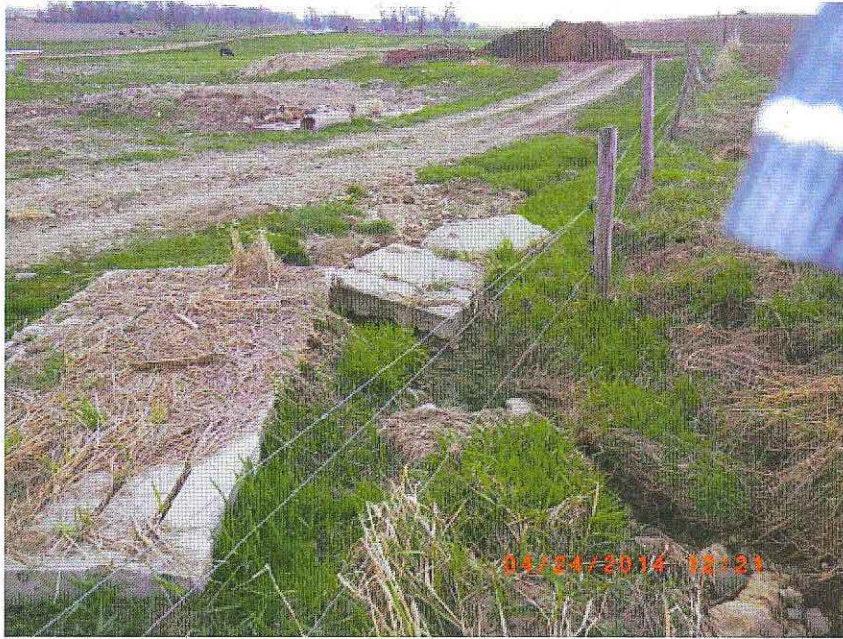
51: IMGP0677

Description: The pathway continues east through this area. Mortality compost pile is located in the background. The mortality compost pile was not covered. Process wastewater from the compost pile had no containment.

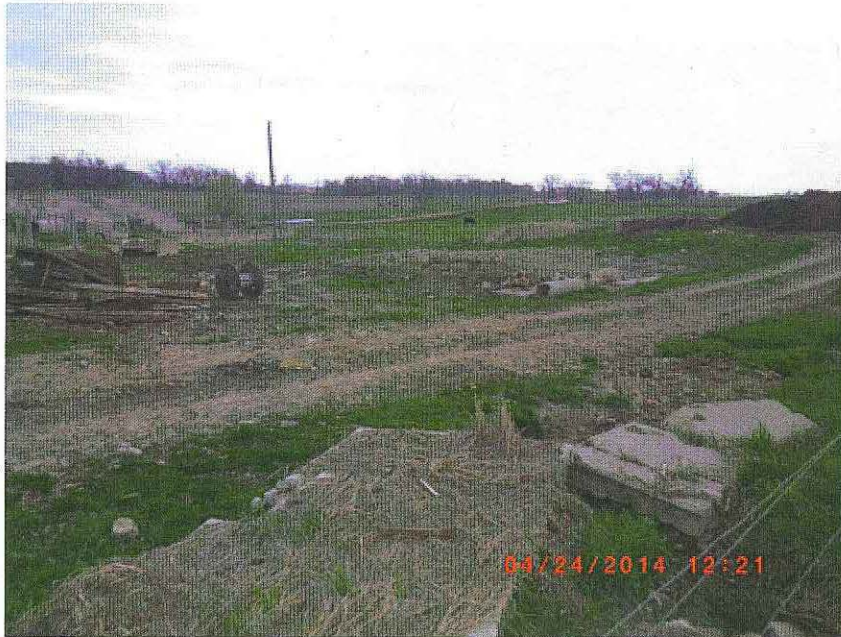
52: IMGP0678

Description: Surface drainage continues east through this area. Mortality compost pile is located in the background. The mortality compost pile was not covered. Process wastewater from the compost pile had no containment.

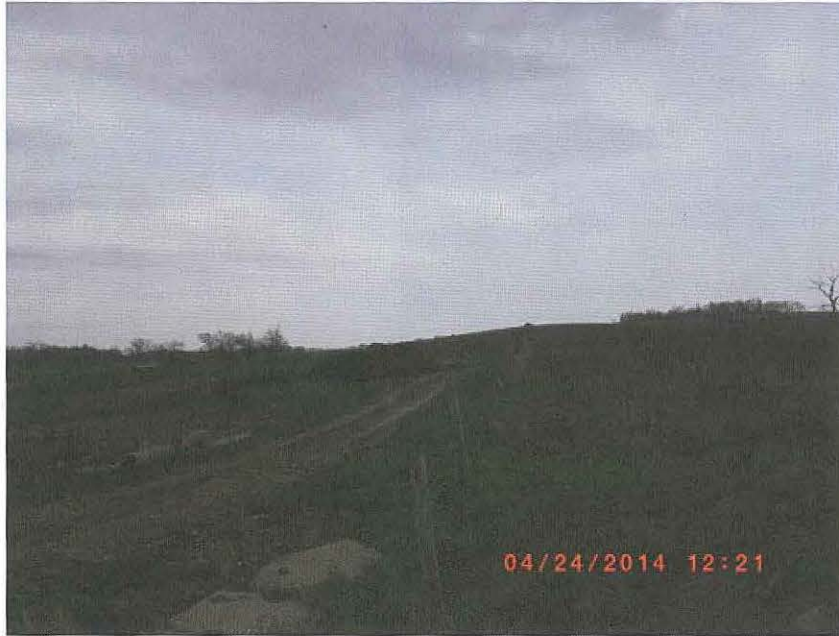
53: IMGP0679

Description: Mortality compost pile is located in the background. The mortality compost pile was not covered. Process wastewater from the compost pile had no containment.

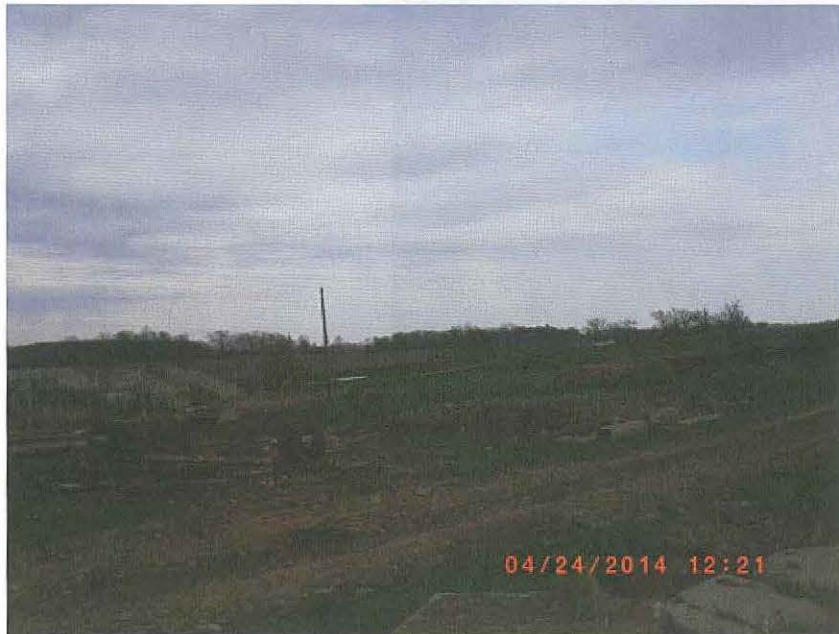
54: IMGP0680

Description: Surface drainage continues east through this area.

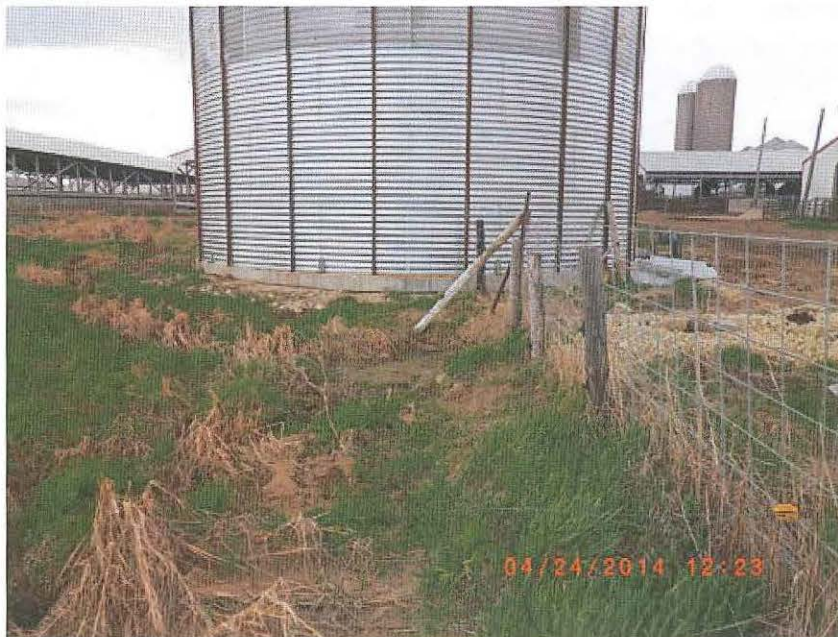
58: IMGP0684

Description: Surface drainage flows east through this grassed area around the grain bins. Vegetation was dead throughout the pathway. Manure solids were observed throughout the pathway.

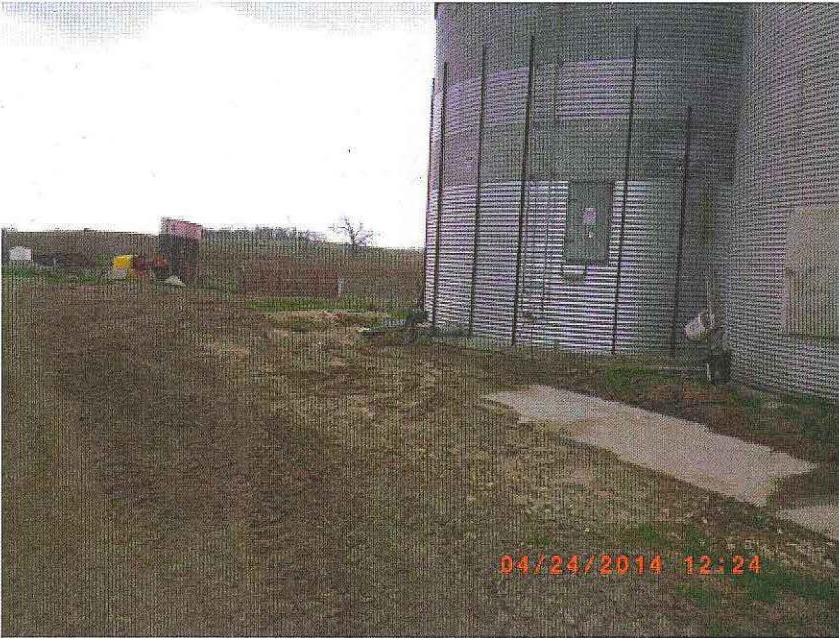
59: IMGP0685

Description: Manure solids were observed along the north end of the grain bins. This area drains east.

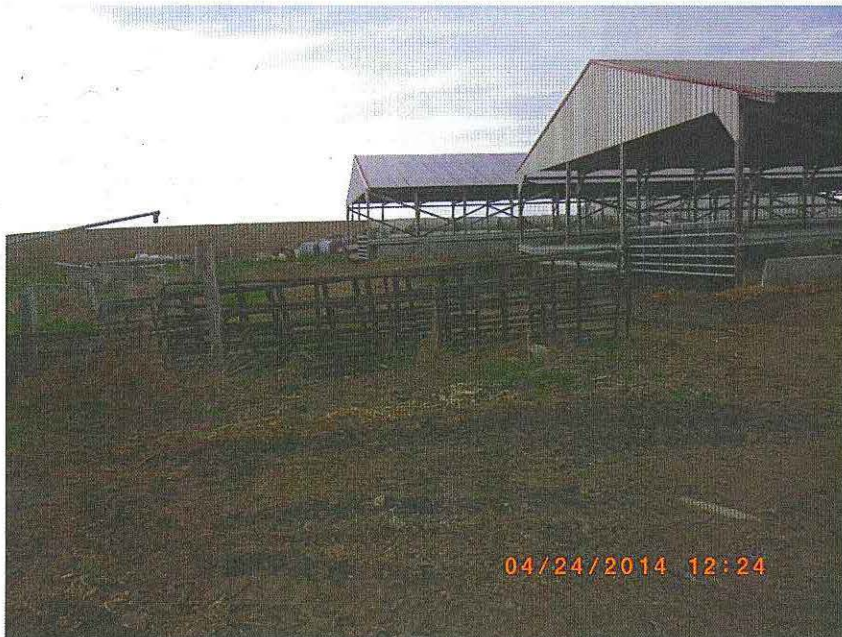
60: IMGP0686

Description: Manure solids and bedding solids were observed in the area east of the Gilt Shed.
